SWIVEL SUIT INFLATOR VALVE

MAINTENANCE MANUAL FOR AUTHORISED TECHNICIANS

Document No. AP 5926

Issue 1
10/01/06

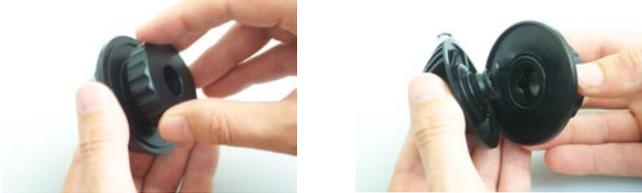
5. Screw the separation tool (AT7009) onto the thread of the valve body (5) until the base (9) and valve body separate. Once complete, unscrew the separation tool from the valve body.

NOTE: The separation tool will become tight and separation of the base (9) and valve body (5) may involve pulling the two components apart once the tool is fully screwed in.
